BA-3079
Anthony Dilworth Farm
12431 Belair Road
Kingsville vic.
c. 1852-60
Private

Maryland Inventory of Historic Properties Form

Inventory No. BA-3079

historic Anthony Dilworth Farm
other

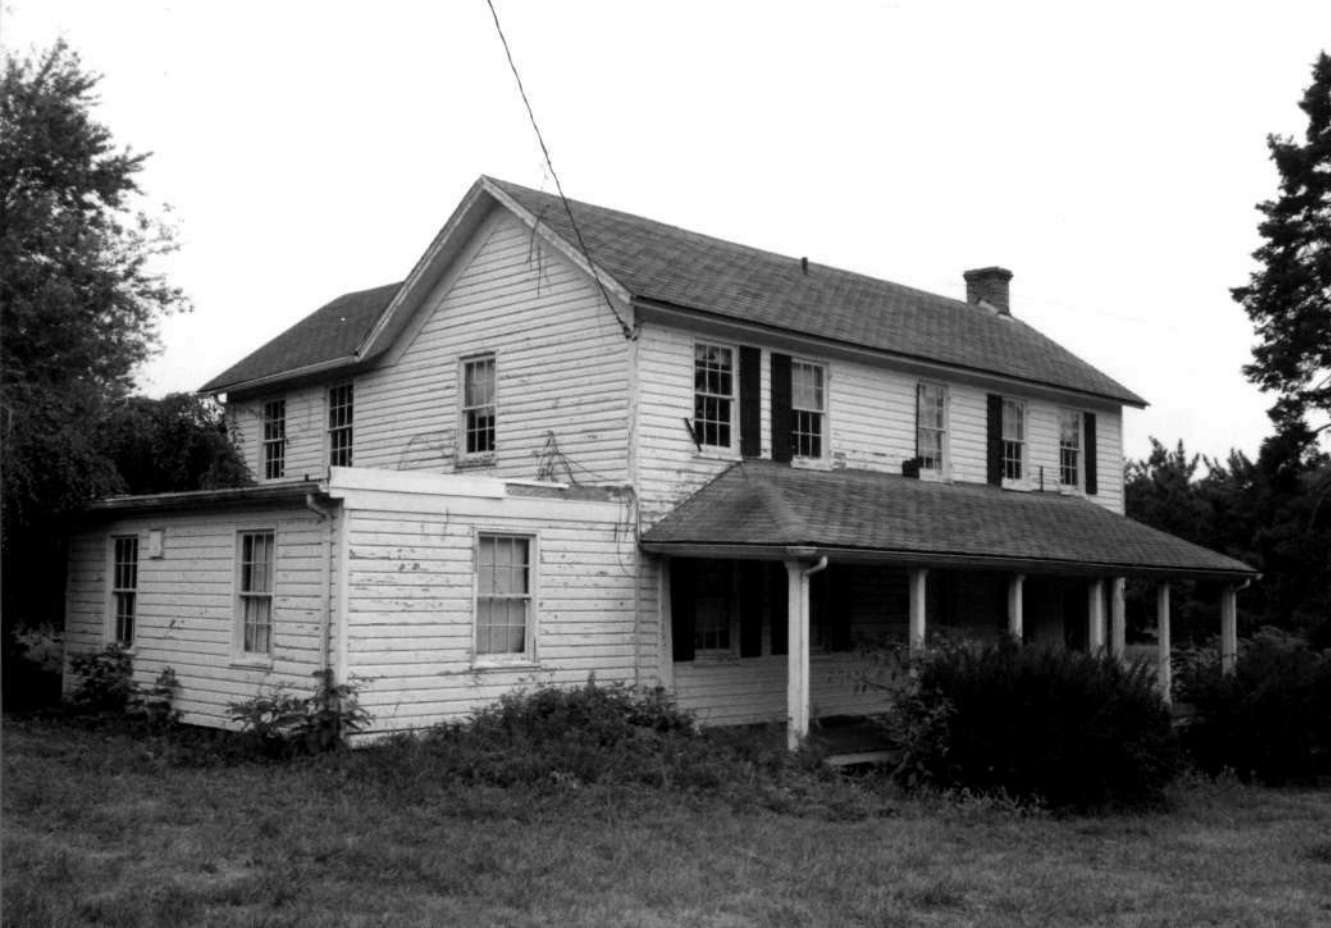
1/3

On the northwest elevation, the first-story north bay has a six-over-six sash with a mitered frame that has a beaded interior edge and shutter hinges. There are fake shutters now at the window. The window has parting beads, but most of them are now missing. This window is typical for the house. The north-center bay has a typical six-over-six sash and the center bay has a four-panel door with sunken fields, quirked ogee and bevel panel moulds, and a typical frame. There is a two-light transom. The west-center bay has a six-panel door in which the top two panels have been converted to lights. The other panels have sunken fields and no panel moulds. There is a back band across the top that has a cavetto, but no back band on the sides. This back band could be covered with parging or could have been removed. The west bay has a six-over-six sash with a plain, wide mitered frame, a wood sill, and no parting beads. There is a five-bay, one-story porch with six chamfered wood posts with simple caps. The half-hip roof has asphalt shingles. There is no evidence that the porch ever had railings. It has a tongue and groove wood deck and a wood soffit of beaded-edge boards with gaps between them. The second story has five typical six-over-six sash. There is an interior brick chimney on the southwest gable end. The eave is covered with a board nailed at the same pitch as the rafters, and there is a plain fascia board.

On the northeast elevation is a one-bay by two-bay, one-story wing with a concrete foundation, German siding, and a shed roof that is almost flat and appears to be covered with tar. This wing has a six-over-six sash on the northeast and southeast elevations, and two on the northwest. All of these windows have mitered frames with a small bevel as a back band. The northeast elevation of the ell has a typical six-over-six sash in the east bay of the first story, and two on the second story. The second story of the main block has one typical six-over-six sash.

House - Northeast & northwest elevs

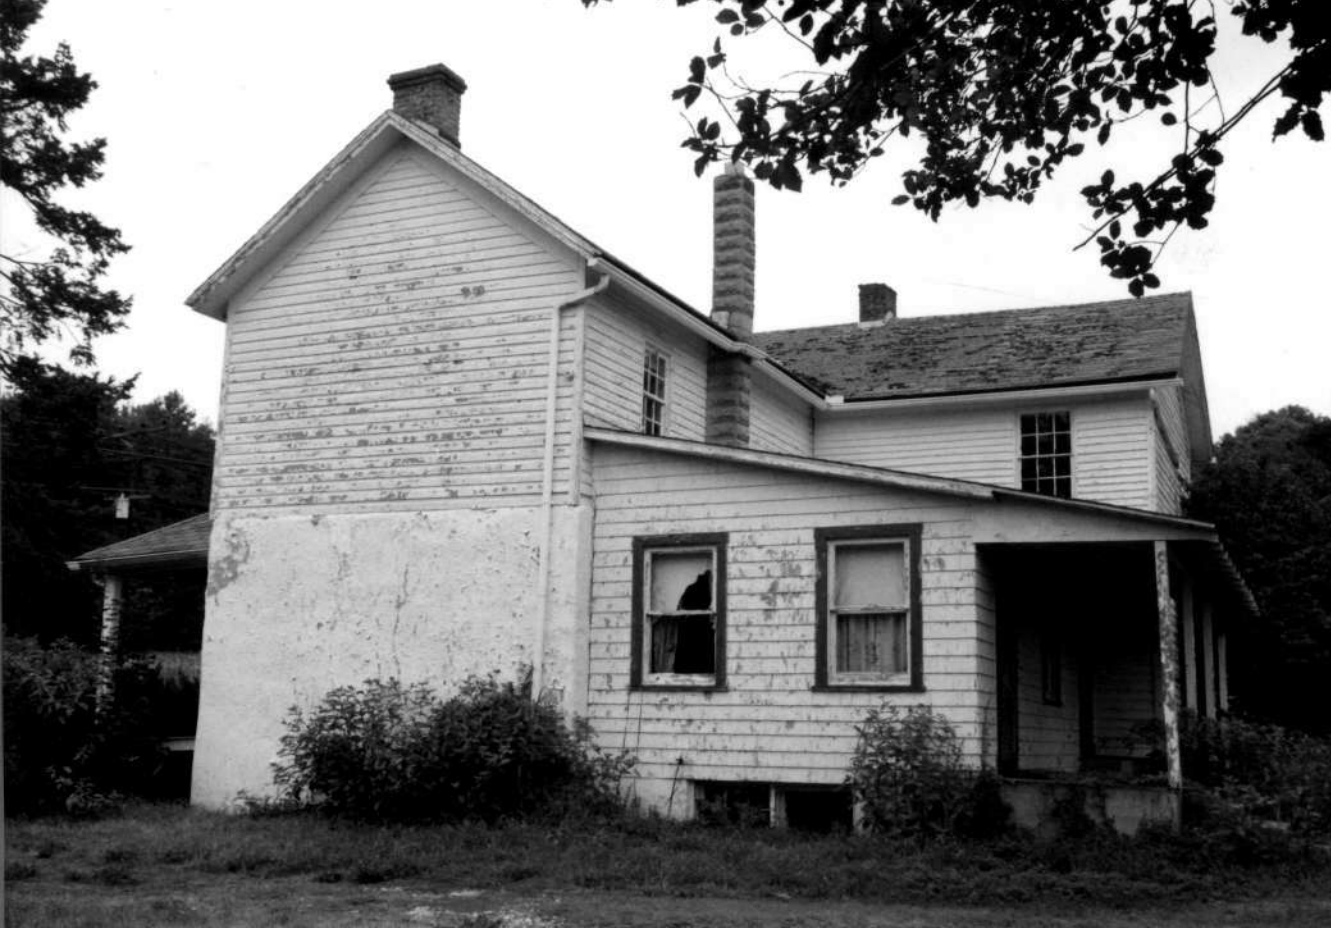
2/3

The first story of the southwest elevation is parged and has no openings. The second story and gable end also have no openings. The south bay of the foundation has a six-light sash with a wood lintel. The raking eaves have fascia boards on the wall. The southwest elevation of the addition has two one-over-one sash with head cut trim on the first story. The foundation has paired six-light sash. The southwest elevation of the ell has a typical six-over-six sash in the south bay of the second story.

The southeast elevation of the addition has a one-over-one sash, like that on the southwest, in the center, and it is flanked on each side by a door with four lights over two lying panels. The doors also have head cut trim. A porch has been added across this whole section. It has a concrete deck and four plain posts. The second story of the main block has a typical six-over-six sash to the south and a rock-faced CMU chimney in the center. The southeast elevation of the ell has a cellar bulkhead door in the foundation. The first story has a door with two lights over three lying panels to the south, and a typical six-over-six sash to the east. The second story and gable end have no openings. There are raking fascia boards like those on the southwest elevation.

House - Southwest to Southeast elevs

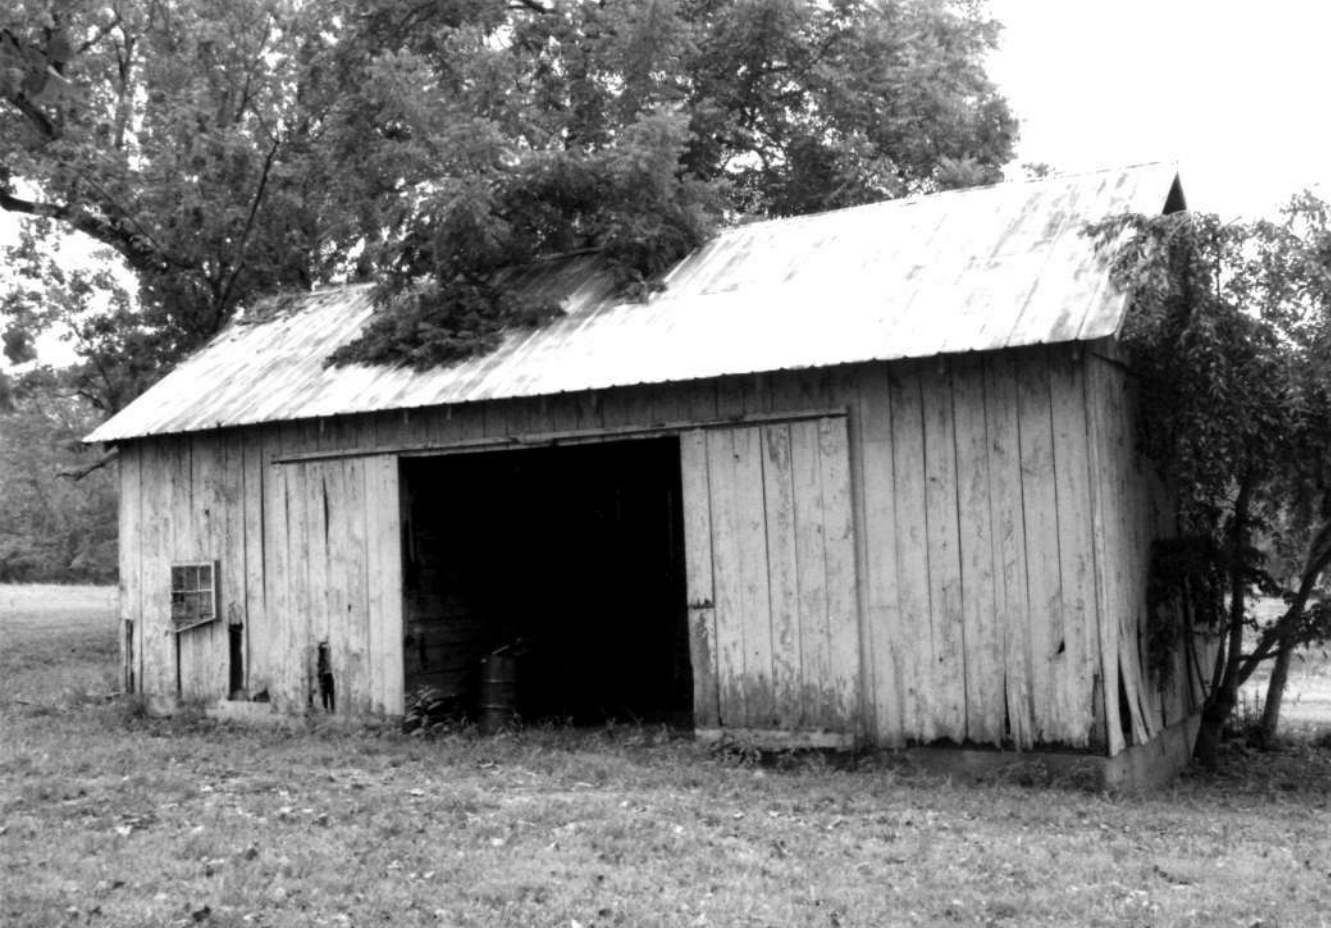
3/3

There is a frame barrack located approximately 100 feet southeast of the house. It has a concrete foundation, vertical-board siding, and a gable roof with inverted-v-seam metal and a northwest-southeast ridge. It is a one-story, three-bay by one-bay structure. The northeast elevation has a pair of wagon doors on rollers in the center and a six-light sash in the east bay. The northwest elevation has no openings. The southeast elevation has a window opening to the south and two door openings to the east. The eastern-most door still retains the bottom half of a vertical-board Dutch door. The southwest elevation has a pair of wagon doors on rollers in the center and a six-light sash to the south. The framing is circular sawn and is fastened with wire nails. It has four by four posts with up braces and two by four rafters that are mitered at the ridge. A board wall divides the southeast end from the center of the barrack, and the southeast end is divided into two pens.

Barrack - northeast elev.
